PHENIX WEEKLY PLANNING

Technical Support 2008

12/18/2008
Don Lynch

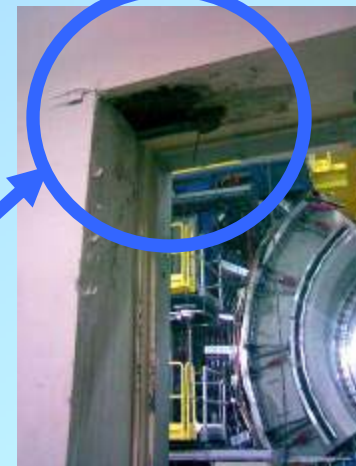
MuTrigger FEE South Rack

MuTrigger South Rack Platform & racks installed, power hooked up cabling and rack cooling in progress

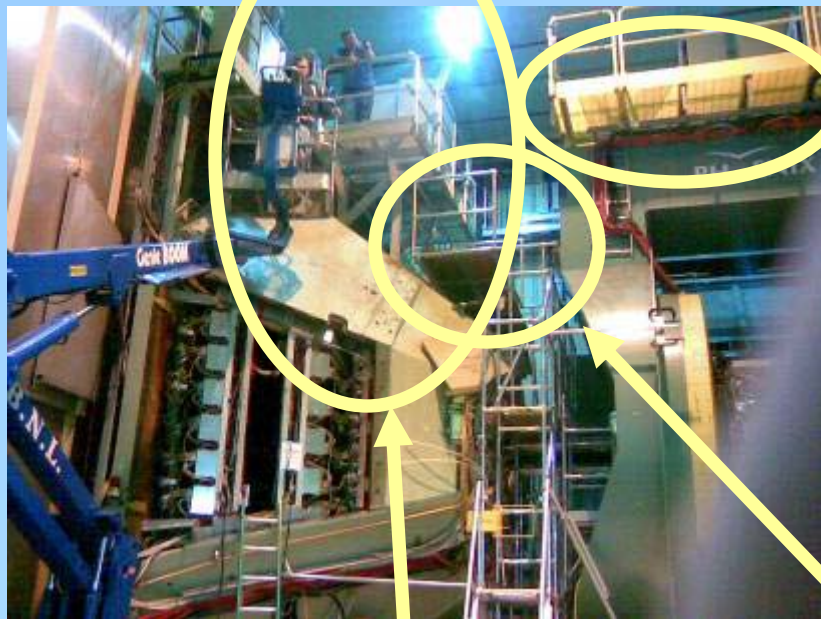
Bridge water manifolds have been reworked...need to be reinstalled

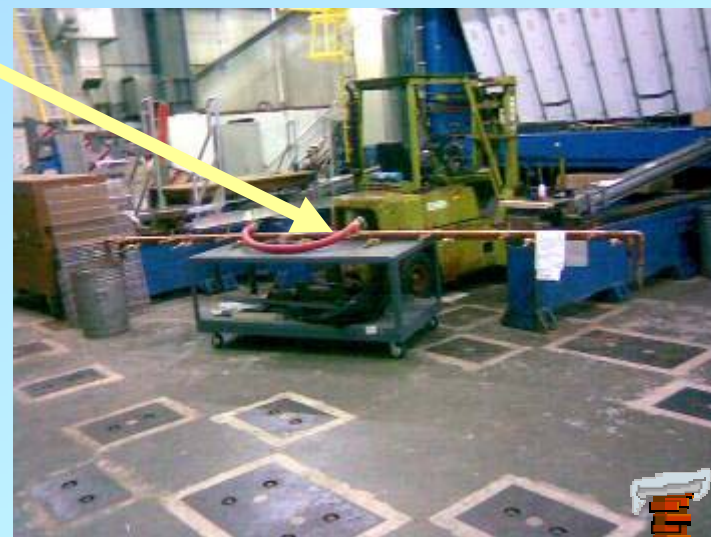
Station 1 South Scaffold modified.. will remain in place until 12/12

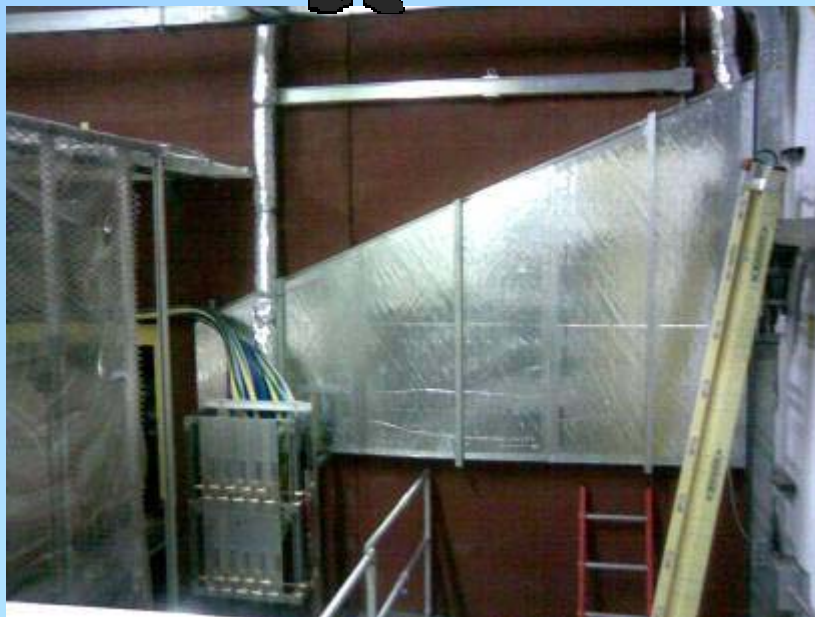
RPC3 Prototype Installation

RPC3 prototype: mechanical
installation is complete;
environmental control installation is
complete; services (gas, signal,
electric) in progress

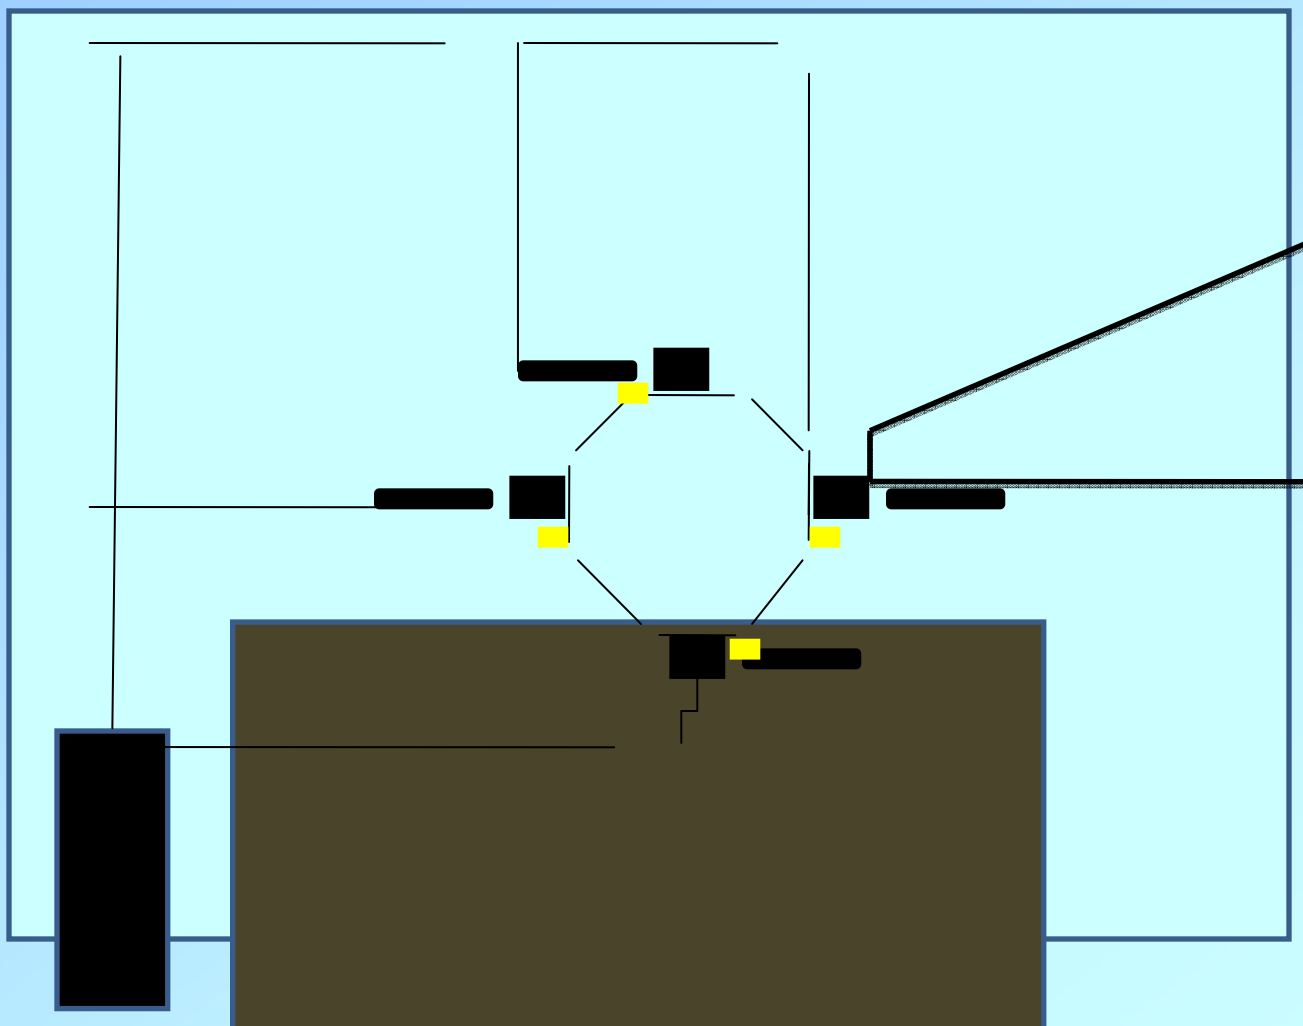
RPC3 Prototype scintillators

- 4 pairs of scintillation counters
- each pair consists of 2 ~1" thick scintillators; active area ~ 2" x 2" ; Length ~10" with phototube and shielding; light guide cylinder ~ 1" dia. With 1" dia PMT's; Weight is ~ 4 lb per pair.
- TLD's: Change and read weekly (quantity and location TBD)
- To be positioned in South tunnel uniformly distributed around the beam pipe at approximately 3, 6, 9 and 12 O'clock at a radially convenient location which overlaps the RPC3 prototype
- Z location is south of RPC3 as close as possible but at most 12" away (for the 3 O'clock pair, others to match z-position)
- Detectors require 2.5 kV to be run from IR.
- 16 channel signal, also to be run from IR
- Rack support is TBD

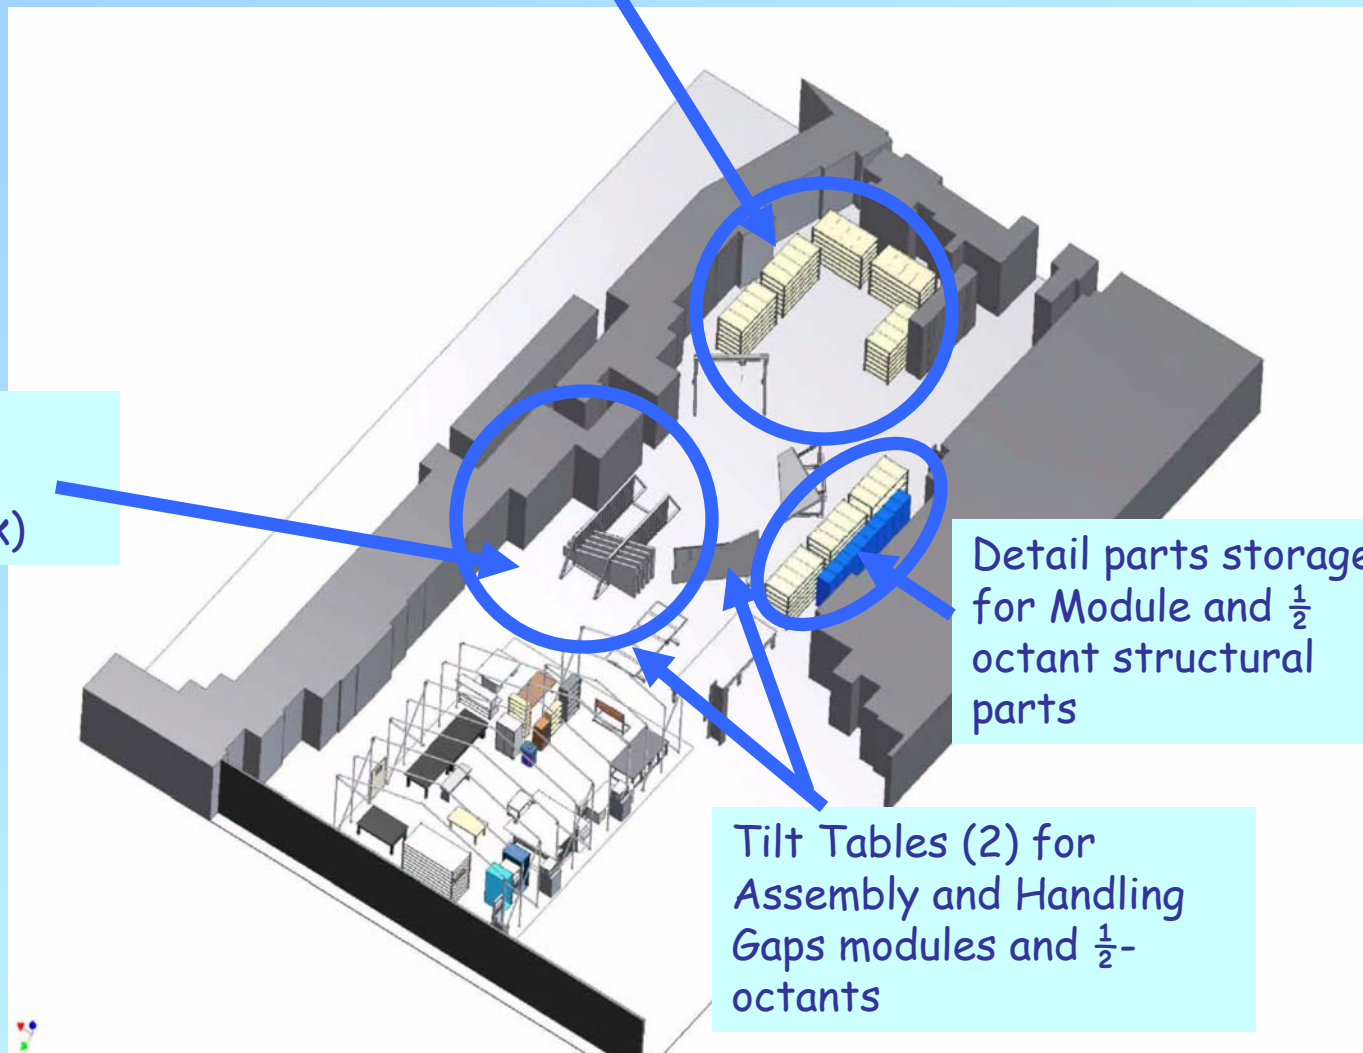
Module and Gap
Storage with
humidity Control

Burn-in
test stand
(bicycle rack)

Detail parts storage
for Module and $\frac{1}{2}$
octant structural
parts

Tilt Tables (2) for
Assembly and Handling
Gaps modules and $\frac{1}{2}$ -
octants

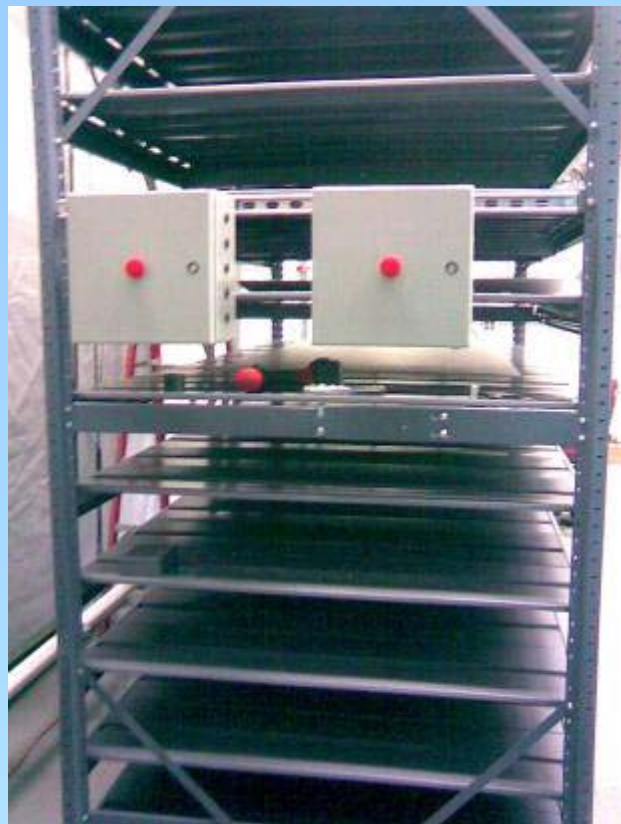
Dark Current Test Stand under construction

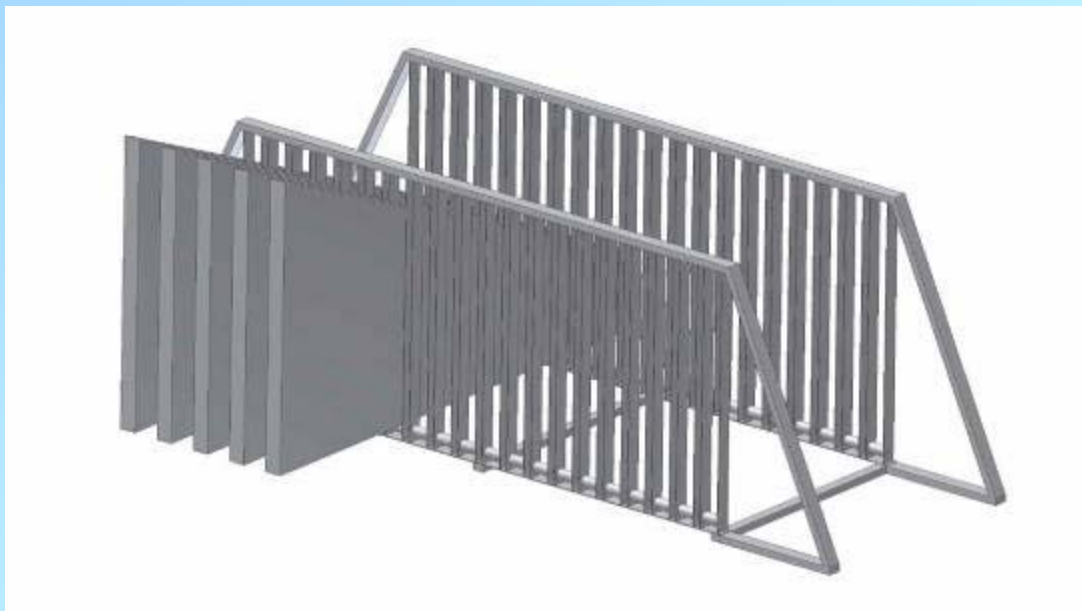
- a burn-in test stand for $\frac{1}{2}$ octants

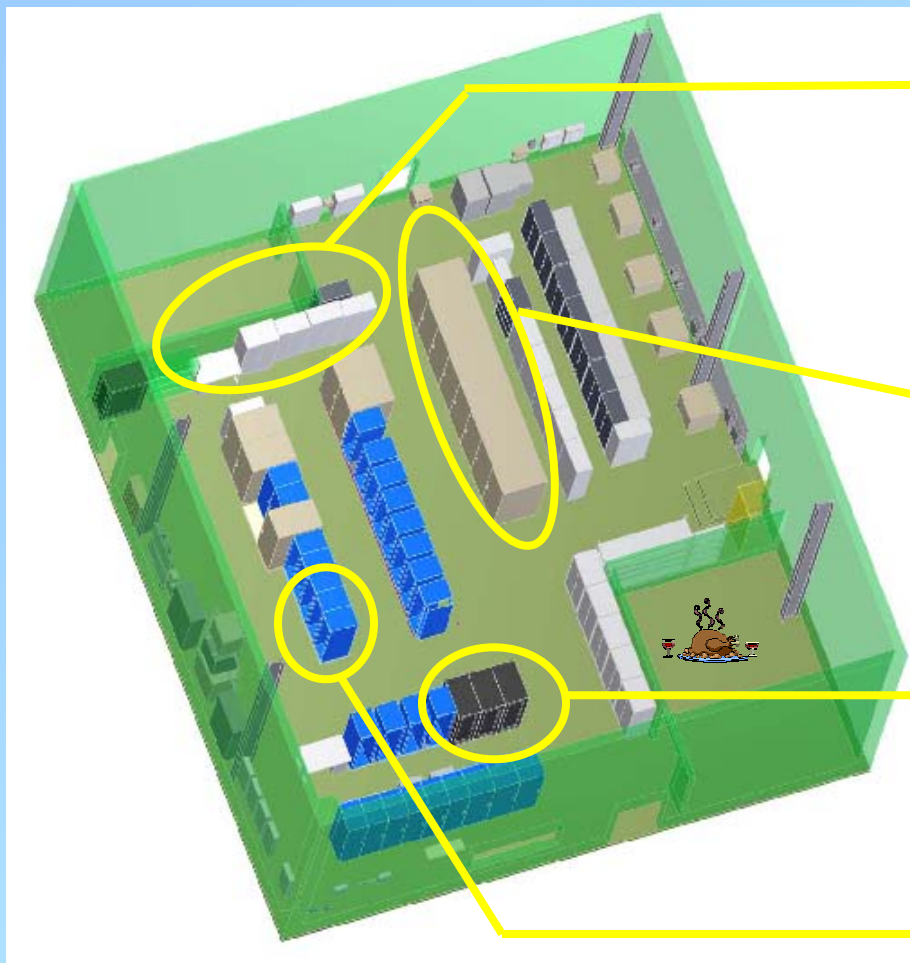
Proposed Reorganization

Relocated file & storage cabinets, & desk

Added 2 DCM racks to east end of row 5 and 2 DCM racks to west end of row 5

Moved 2 large black racks from row 4 and added a third large black rack to row 2

Moved tall blue (open) rack from north end of row 2 to east end of row 3 and added another of the same to row 3

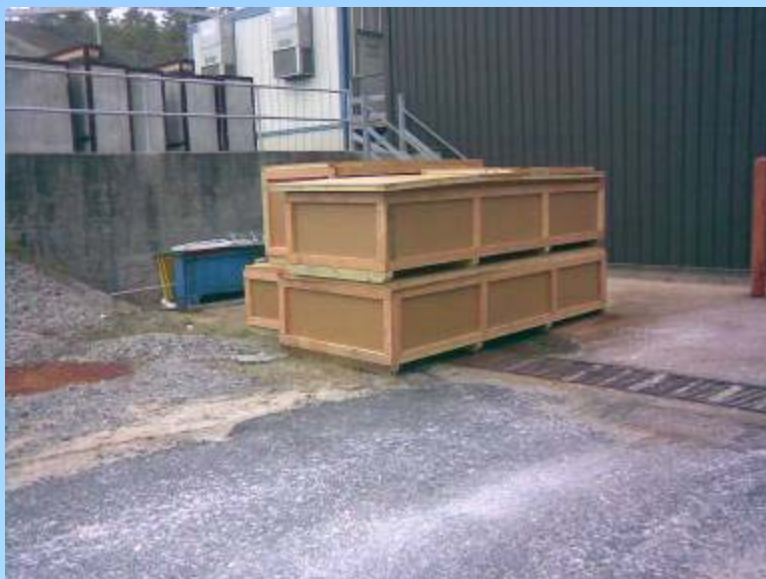
Scaffolding Crates

New Crates for Sta 2/3N scaffolds and Sta. 1 scaffolds are Done.

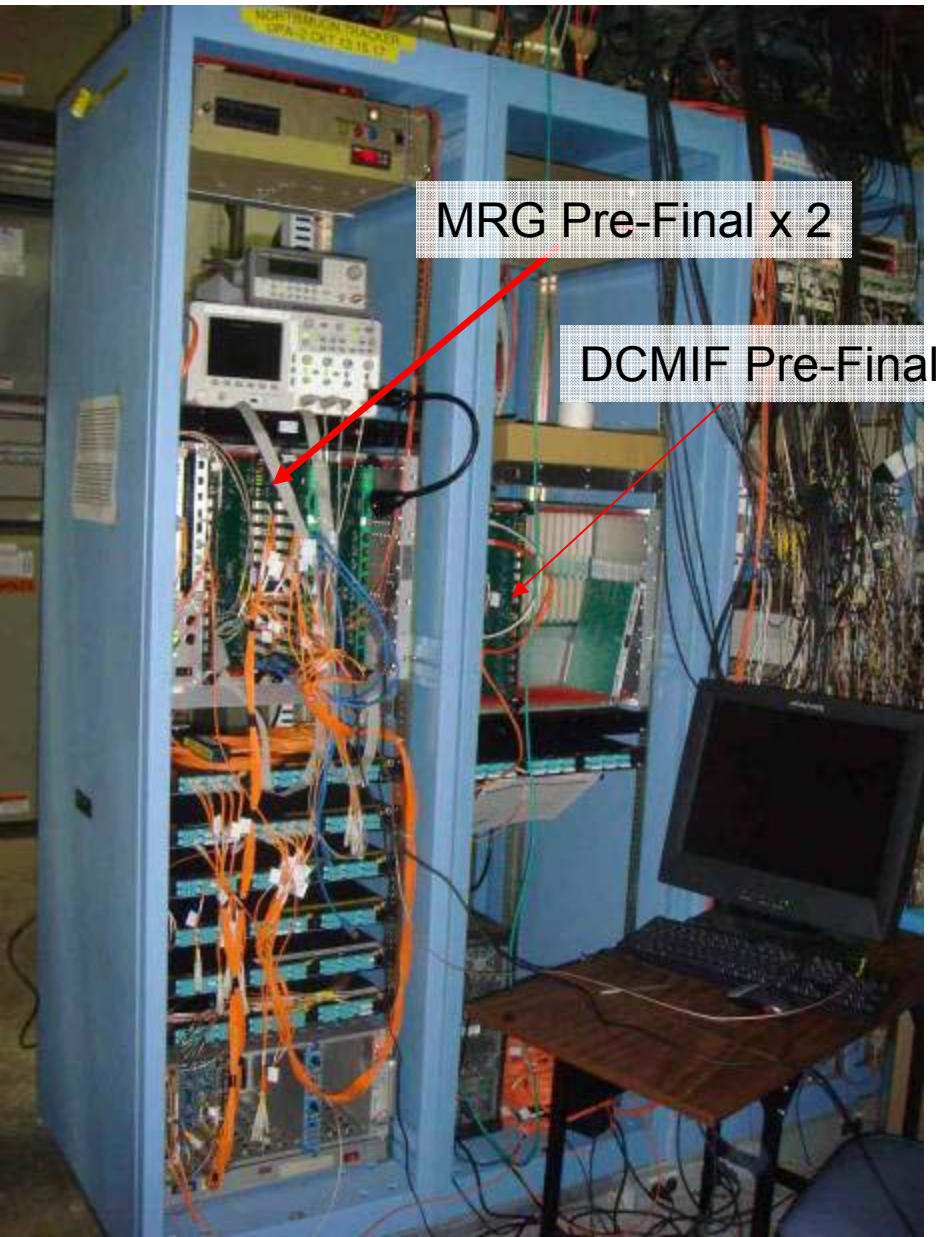
MRG Status

- MRG Pre-Final Version
 - Tested OK
 - Started Production 12/15
 - Expected Delivery ~ 2/1
- DCMIF Pre-Final Version
 - Testing
 - Start Production 12/22
 - Expected Delivery ~2/1
